# TOLEDO HARBOR LIGHTHOUSE

## SUMMARY OF TASK ONE/PHASE ONE - TECHNICAL REPORT

Toledo Harbor Lighthouse  
Maumee Bay at Lake Erie  
DAP Commission No. 05021

## BUILDING CONDITION ASSESSMENT REPORT

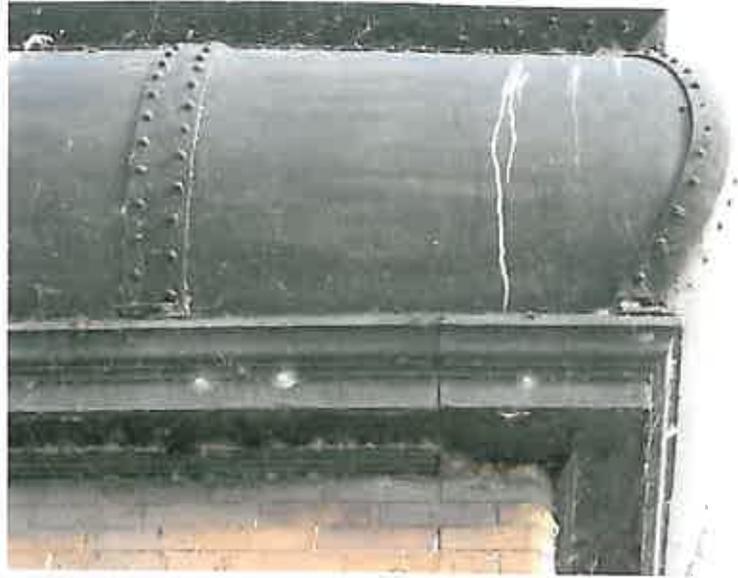
**Photo 5 Engine Room  
cornice repair (NE)**

Cast iron trim covering the roof edge termination at the masonry wall line is largely intact and in excellent condition. One missing trim piece at the northeast corner of the Engine Room will be repaired or replaced (Photo 5).

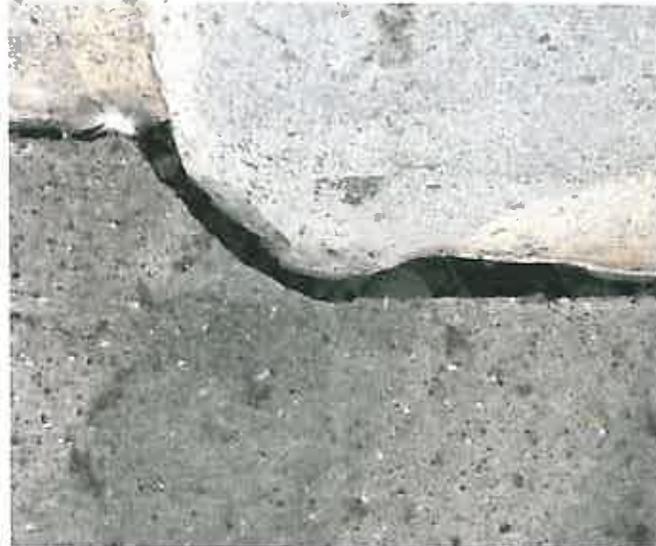
**Photo 9 Base of Limestone  
Water Table**

Repairs done in 1989 included a new concrete deck over the platform utilizing elastomeric joint seals that are failing. There is also a substantial gap at the perimeter of the building with no expansion joint filler (Photo 9). Both conditions are primary contributing factors to uncontrolled water entry into the basement. New remedial joint sealants and deck coating will be included in the scope of renovation work.

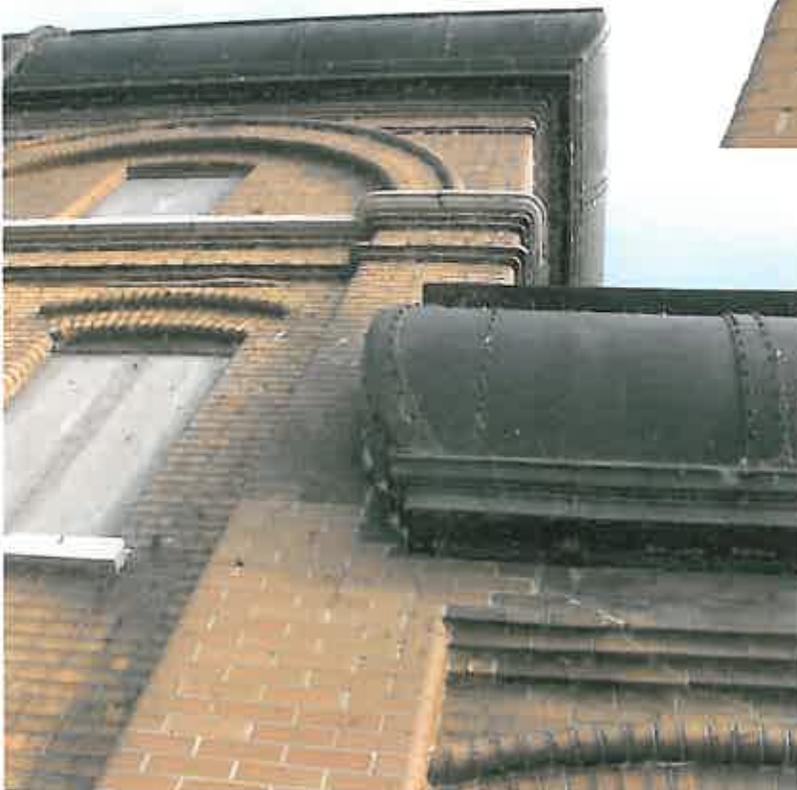
**Photo 11 Limestone cornice  
repair (1989)**

Some carbonation of the limestone is observed, but there is only slight degradation (peeling) of a few units and no exfoliation. There is physical damage to the face, corners and underside on a few of the window sills that will require patching (Photo 10), but for the most part the stone is in excellent condition. The limestone cornice belting exhibits signs of greater wear from exposure with some visible cracks and displacement of previous repairs (Photo 11). These will be properly addressed during the renovation.

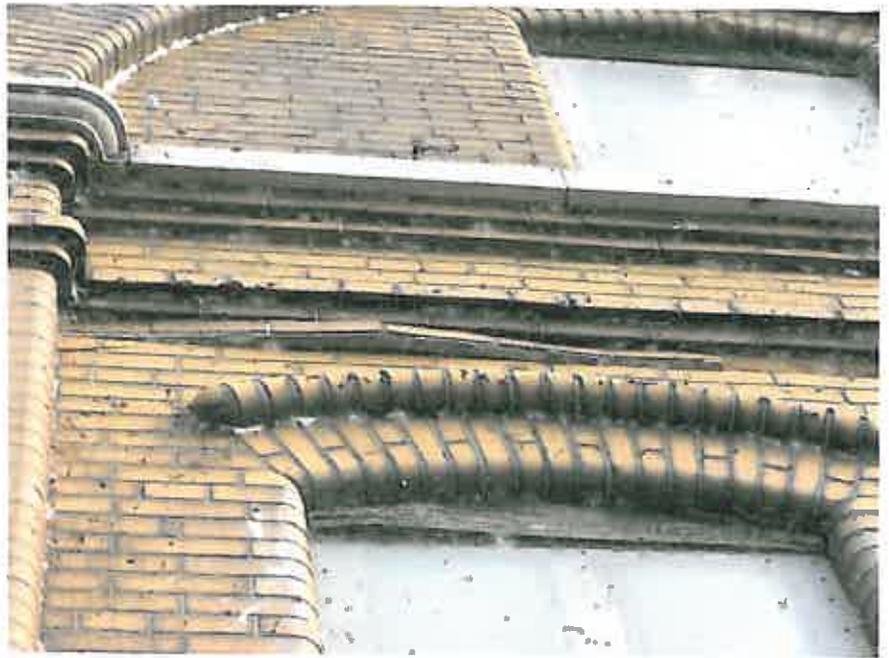
**Photo 13 Brick  
compression below  
Limestone Cornice**

There is notable brick deterioration found in the top course of the infill wall on each face of the Tower beneath the corbeling. This condition is indiscernable in the 1989 document. Displacement and compression damage has destroyed the exterior face of the brick along the infill wall this location and the remnants of this course are displaced in a bowed manner with the ends of the brick restrained at the pilasters (Photo 13).

The degradation to the face of the top course of brick beneath the corbelling supporting the limestone cornice belt is classic spalling. The pattern and depth of dislocation appears to be more severe than would be expected from expansion cused by internal corrosion. The damage to the brick face is consistant with a hard portland cement mortar intefering with normal expansion and contraction cycles.

An alternative cause of the compression failure in the upper course of masonry would be differential building movement. The roof structure and steel plate cladding act as unit similar to an inverted boat hull. Under extreme weather events, imposed lateral forces acting oblique to the wall plane would not be restrained by the masonry shear wall action, falling outside the intended load path. Any resulting unrestrained forces could easily cause the type of compression cracking at the floor line combined with tension fractures in the pilasters which have been observed. The harder portland cement mortar would likely concentrate

pressure on the brick face that would normally be absorbed in the wall construction. This will be investigated and repaired during renovation.

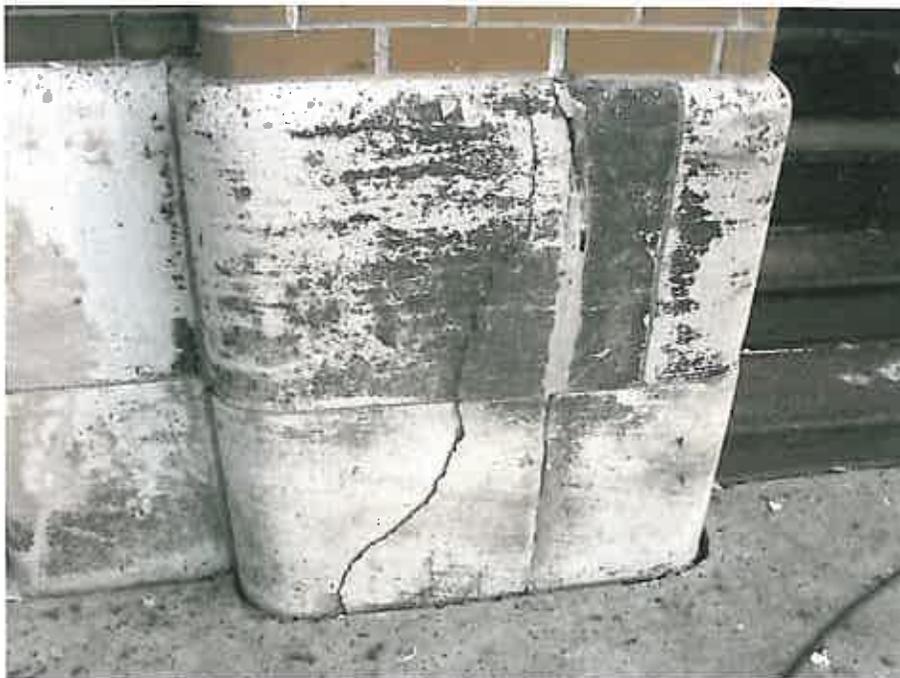
**Photo 14  
Limestone  
Fracture at  
Pilaster base**

The attached photo shows a large vertical fracture at the base of the pilaster at the northeast corner of the main building entrance (Photo 14). This is the only stone in the building perimeter which exhibits this type of damage. The split is adjacent to previous repair work done in 1989. It is of interest that displacement is perpendicular to the wall plane with no dislocation vertically or parallel to the wall plane. This unique condition occurs at the point where the steel framed Tower abuts the load bearing masonry Engine Room.

The absence of similar damage on the opposite side of the structure indicates the wall opening at the entrance may be a contributing factor. A review of the drawings confirms no perimeter steel framing at the first floor line, which further suggests the crack may result from stress relief due to differential movement between the Tower and Engine Room, and not the consequence of a thermal, freeze/thaw or weathering process. There is also a pattern of hairline cracks in the replacement brick pilaster above the fracture that are not visible in the photographs. These are similar to the damaged original pilasters and further indicate some stresses from flexure or movement at this location.

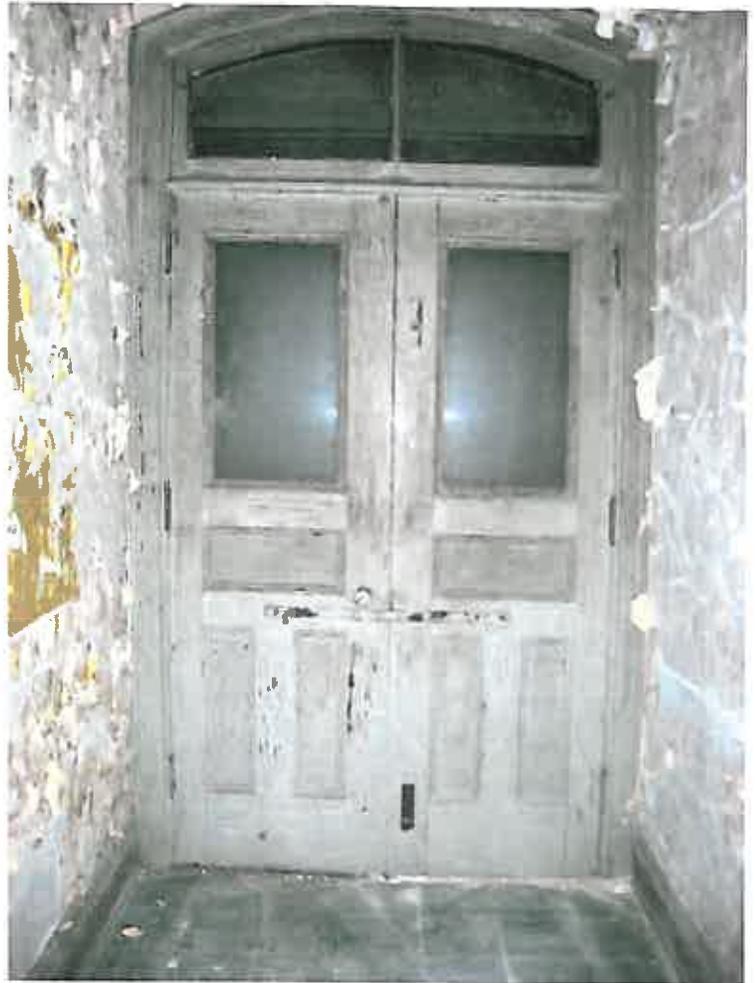
**Photo 15 Main Entrance**  
**Interior view**

The pair of glazed wood doors remain intact in their original location, although the wall opening has been sealed up with concrete masonry (Photo 15). These will be restored to their original condition at the date of construction (1902). A protective storm door or overhead coiling grille will need to be added for security and to protect the restored millwork. The bottom tread is cracked and will be repaired (filled or welded-Photo 16). The cast iron sill at the Engine Room double door is also cracked. All cast iron will be cleaned, repaired and refinished.

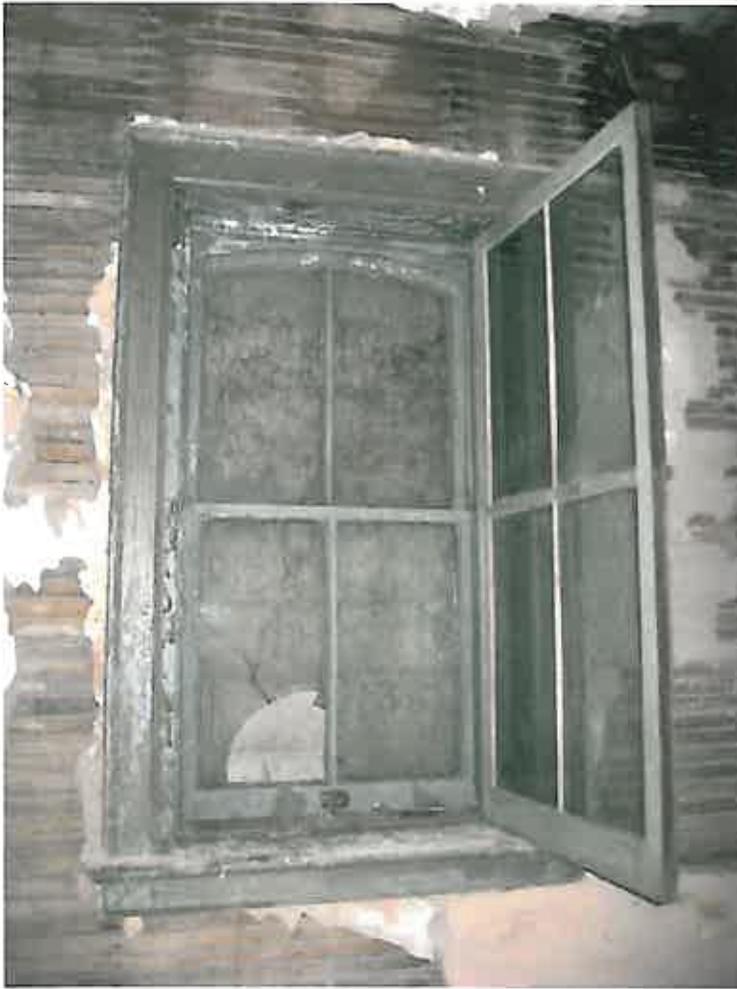
**Photo 19 Office 107 –  
Original Window**

There is a modern replacement window (double hung painted wood with spiral sash balance mechanism) in one opening on the northeast side of the Engine Room that has been filled on the exterior with concrete masonry. There is a single original window with storm shutter intact and damaged sash in the Engine Room Office in an opening that has also been filled (Photo 19). This will be removed and restored for display purposes.

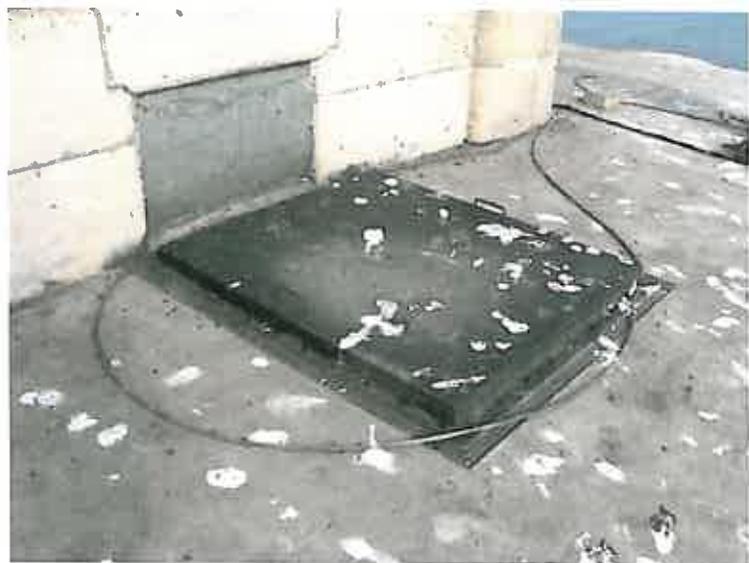
**Photo 20 Hatch cover**

The original hatch covers were hinged steel fabrications of a bifold design set flush with the concrete deck. These have been removed and replaced with modern curb mounted steel lift-off type hatch covers that are leaking and in generally poor condition (Photo 20). These will need to be replaced.

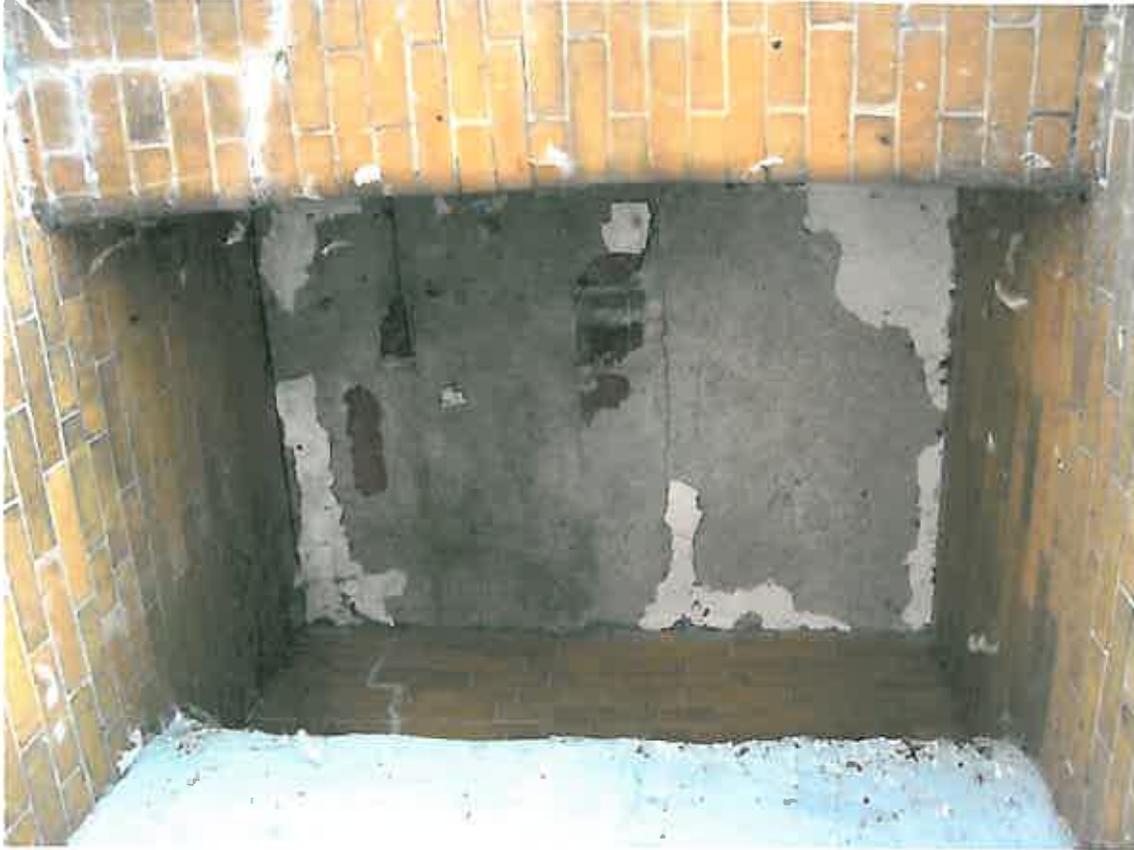
**Photo 21 Soffit at Entry**

The plaster soffit at the recessed main building entrance is deteriorated and will require a new plaster finish on the existing clay tile surface (Photo 21).

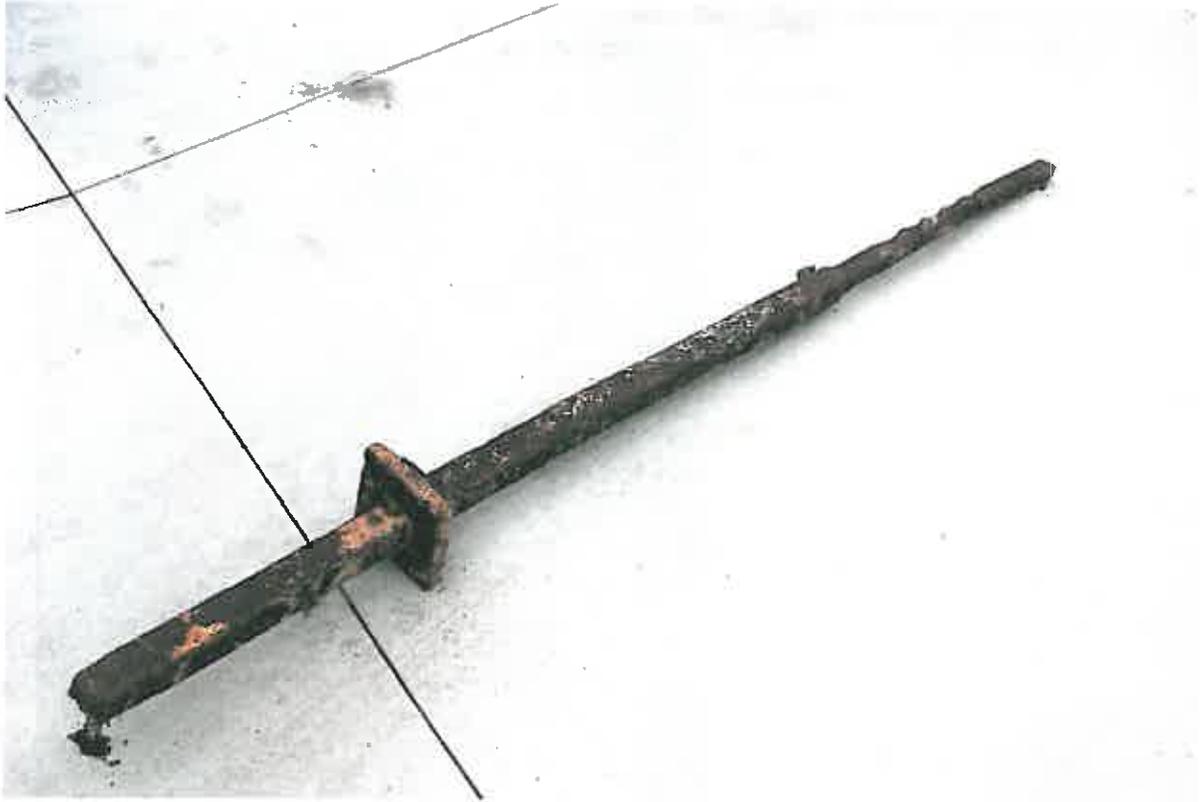
**Photo 22  
Safety railing  
(undated)**

The original concrete platform was covered with a wood deck, later abandoned. The concrete has a contemporary top slab added during the 1989 repairs that is in good condition. The original post and chain safety rail was removed in 1989, patterns for the stanchions have been located and will be used to replicate the railing (Photos 22 and 23).

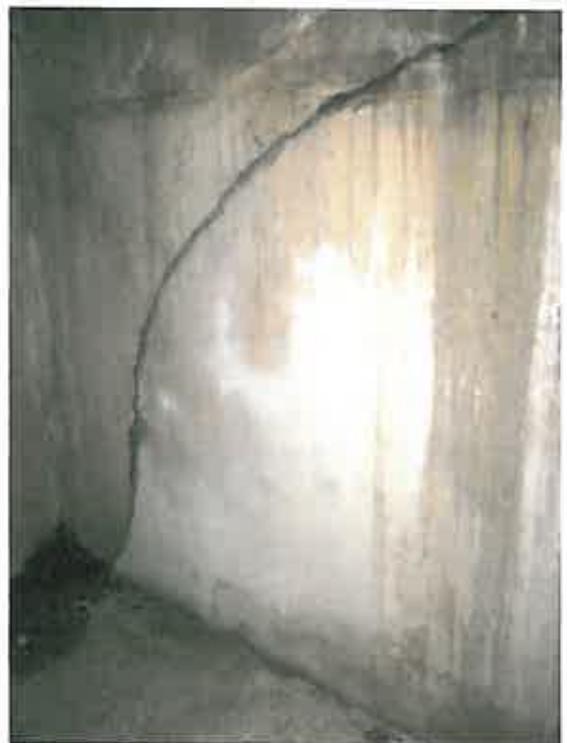
**Photo 24 Interior vault wall  
(Basement)**

All Masonry construction. One wall in the basement vault area has a shear crack where it abuts the perimeter crib. This wall is indicated to be plaster on brick masonry in the drawings, visual inspection appears to be cast-in-place concrete (Photo 24).

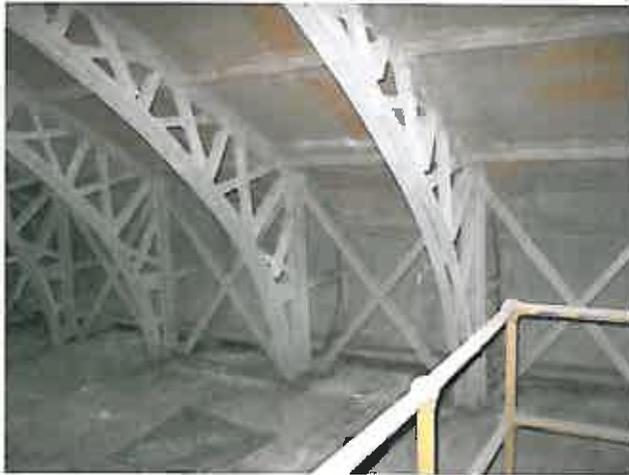
**Photo 30 Engine Room Attic**

The entire underside of the steel roof is visible from within the structure and shows no evidence of moisture intrusion. Paint/coating in the watchroom has deteriorated and will require removal (Photos 30 and 31). The unpainted surface in the Engine Room attic shows minor surface oxidation characteristic of iron silicate contained in wrought iron. Modern steel sheets added to cover the original clerestory windows have extensive oxidation and will be
