## **Chagrin River Watershed Partners, Inc.**

### **Green Infrastructure Design & Construction Case Studies**

**November 2009**

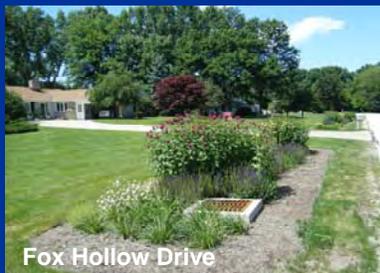
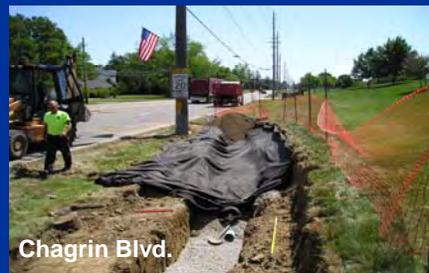
- Modify existing drainage swale and install bioretention in residential & public areas.
  - Fox Hollow Drive – Residential Subdivision
  - Chagrin Boulevard – Orange Campus High School

- Goal is to provide option to ditch culverts.

- City approached homeowners for involvement
- Maintained by City for 3 years
  - Landscaping becomes responsibility of homeowner
- Develop a planting plan for installers and homeowners
- Cost to Install: \$57/LF
  - 800 LF of Bioretention
  - Installed by City Service Department
  - Project total \$45,000

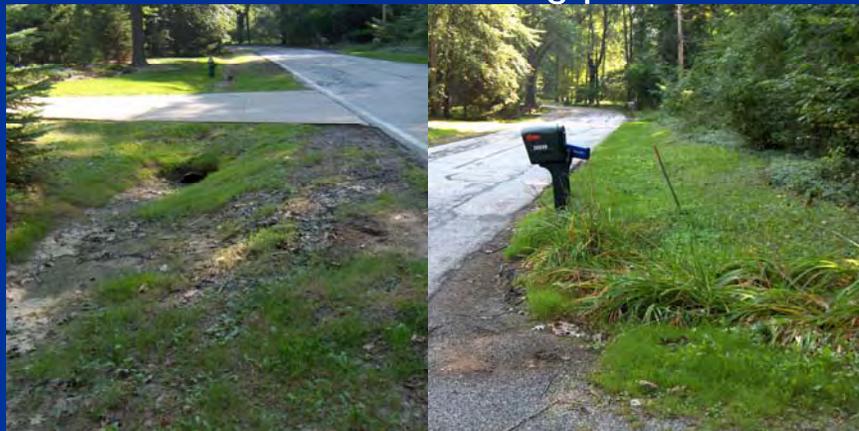
Replace existing storm system with bioswale system along the north and south sides of Sterncrest Road to fix flooding problems.

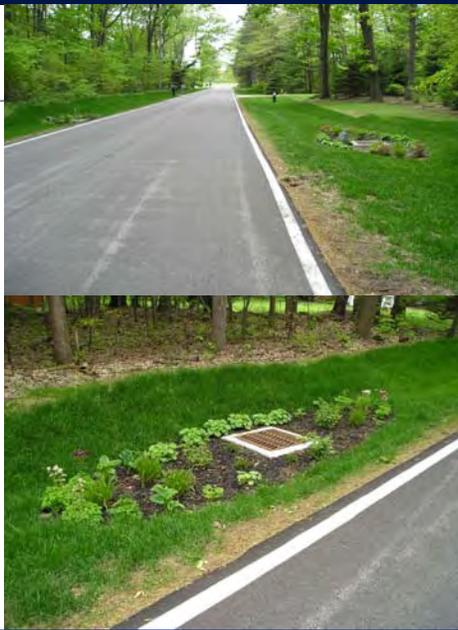
# Sterncrest Bioretention

- Cost to Install: \$115/LF
  - 1100 LF of Bio-Swale
  - 1100 LF storm sewer pipe
  - 9 Bioretention Areas
  - Sod installation for swales – immediate stabilization
  - Project total \$126,000
- Can save on cost by having the service department install plants

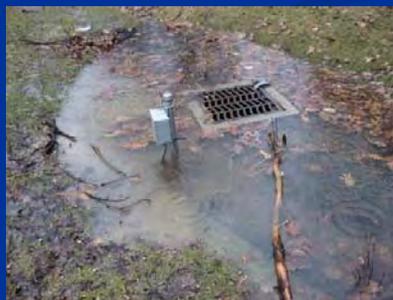
- Dissolved Total Nitrogen
- Total Phosphorus
- E. coli
- Chloride
- Dissolved Metals
- Total Metals
- TSS
- Turbidity

- Water Quality samples are taken from:
  - Storm water ponded around catch basin
  - Lysimeter samples of water extracted from soil
  - Catch basin/underdrain flow
- Water Quality data limited because 10 events with surface runoff were available to sample.
- Data provides evidence of treatment during movement of storm water through the bioretention cell.

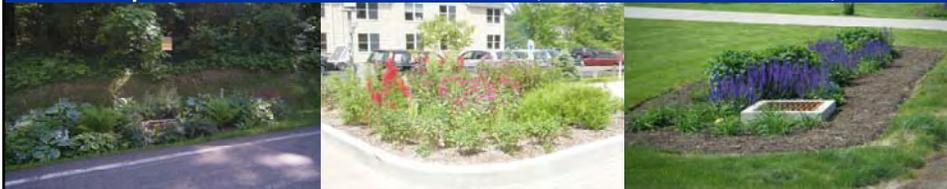
- Ammonia (NH<sub>3</sub>) – Nutrient available for plant uptake, but toxic to aquatic organisms at high concentrations
- Overall low concentrations – not a pollutant of concern at these concentrations
- Higher concentrations in soil water (Lysimeter)
  - Due to decomposing organic material, low levels of plant uptake, and slow nitrification (conversion to nitrate)
