Chagrin River Watershed Partners, Inc.

Water Quality Treatment and Runoff Reduction Performance of Roadside Bioretention

August 5, 2009

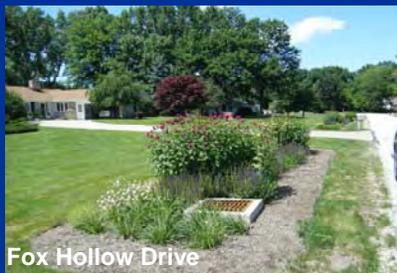
- Modify existing drainage swale and install bioretention in residential & public areas.
 - Fox Hollow Drive – Residential Subdivision
 - Chagrin Boulevard – Orange Campus High School

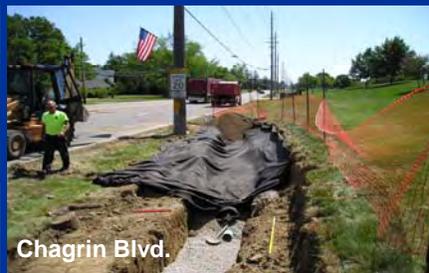
Chagrin Blvd.

- Goal is to provide option to ditch culverts.

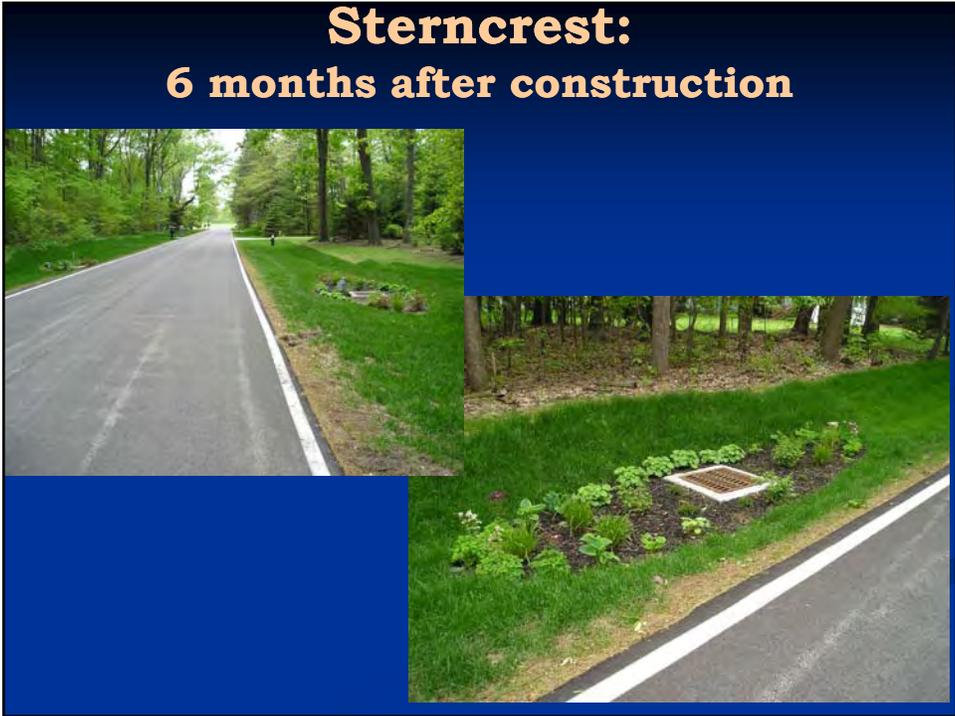
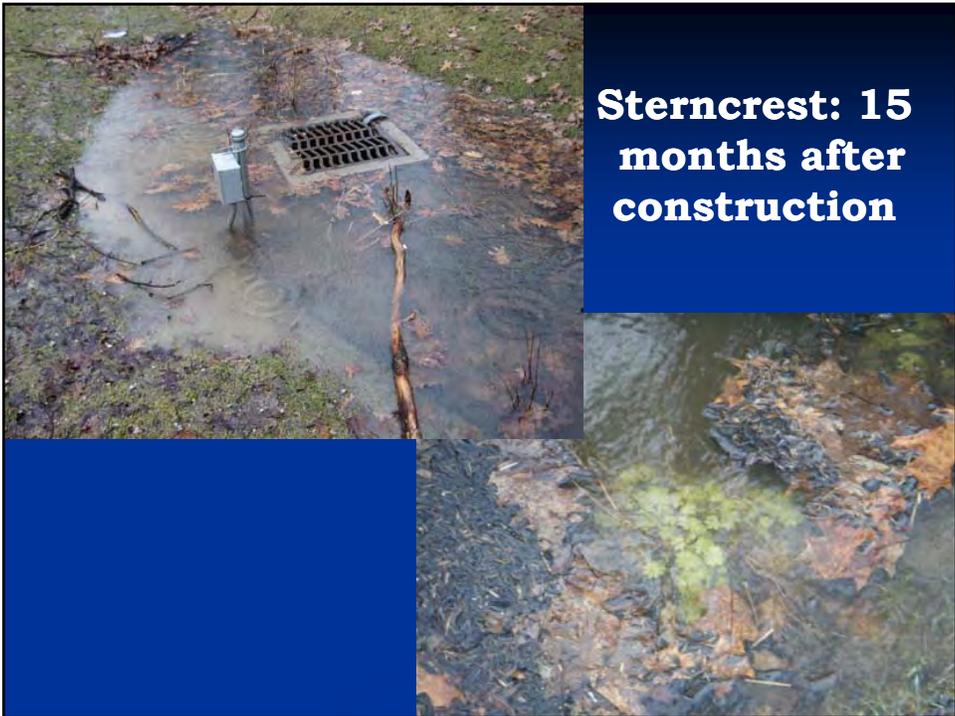
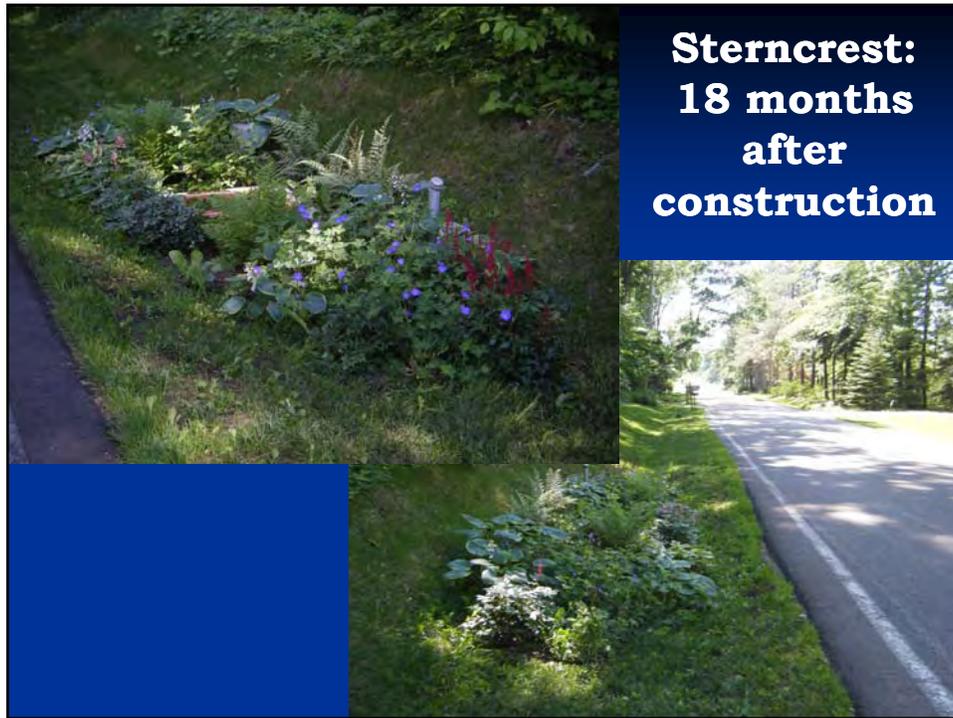
- Bioretention and bioswales designed for WQv.
- The soil mix design 70/30 mix with compost material instead of peat.
- Organic Leaf Compost: MN DOT Grade 2.
 - Minimum organic content 30%
 - C/N Ratio of 6-20:1
- Sand - AASHTO M-6/ASTM C-33
- Edger between bioretention area and swale sod

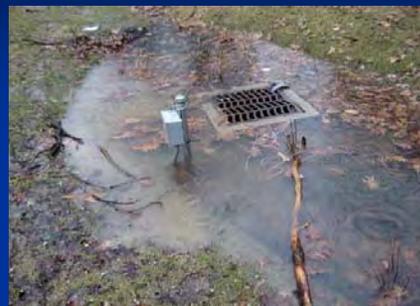
Monitoring Equipment

- 4 Suction lysimeters in bioswale areas near catch basin
 - Small well to sample quality of water in the soil
- Conductivity sensor in the catch basin to measure overflow duration
- Rain gage
