# Roadside Ditch Sediment Control Project

**Final Technical Report: July 2012**  
**Lake Erie Protection Fund Award – SG 415-11**

## Summary of Roadside Ditch Stabilization Best Management Practice Demonstration Sites in Geauga and Lake Counties

Demonstration Site Summary Report: July 2012  
Lake Erie Protection Fund Award – SG 415-11

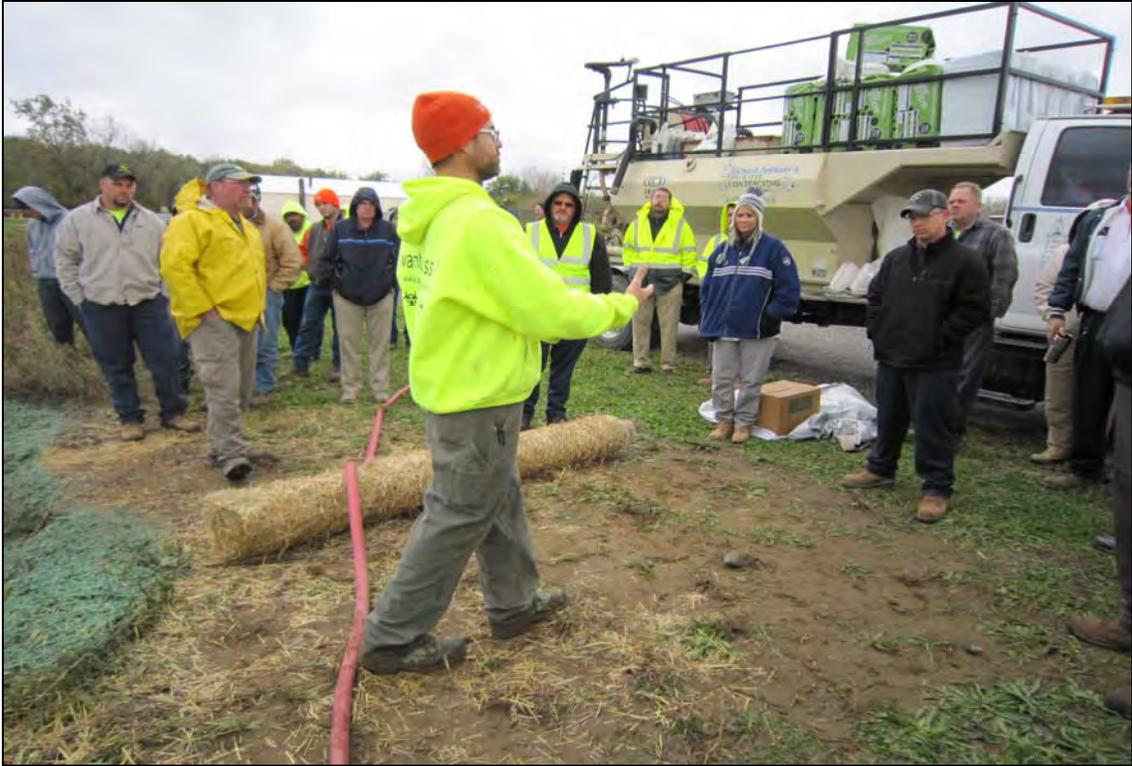
**Figure 1.** Absolute Contracting, Inc. providing field demonstration of wood fiber hydro mulch materials using a Finn T-120 hydro seeder during the October 21, 2011 training.

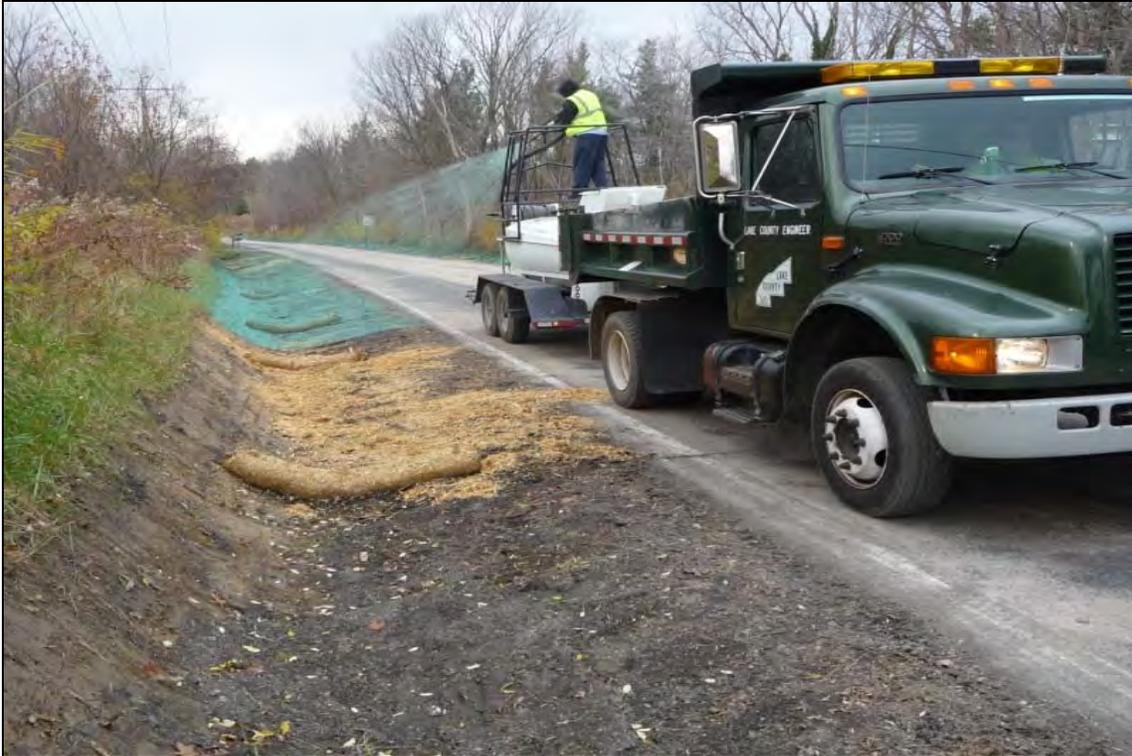
**Figure 2.** Lake County Engineer application of straw wattle and wood fiber hydro mulch at the Ledge Road demonstration site in Madison Township, Lake County.

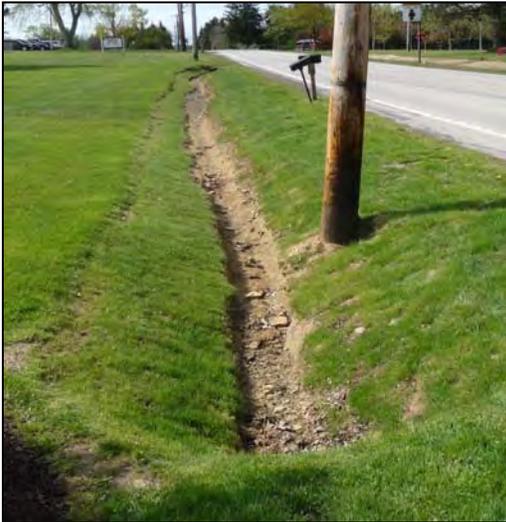
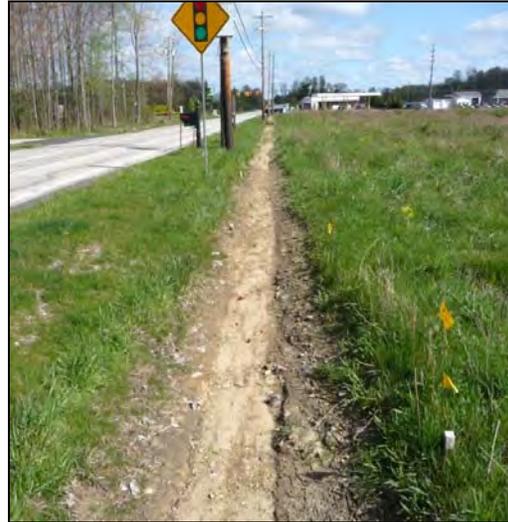
**Figure 3 and Figure 4.** Established vegetation on the fore slope, back slope and roadside berm (left, Figure 3) using wood fiber hydro mulch at the Bass Lake Road demonstration site in Munson Township, Geauga County. Failed vegetation with paper hydro mulch application at Bass Lake Road (right, Figure 4).

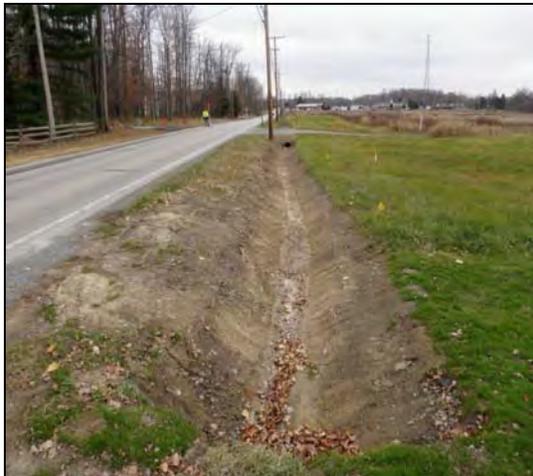
**Figure 1.** Bass Lake Road, Southern Treatment Zone prior to BMP installation.

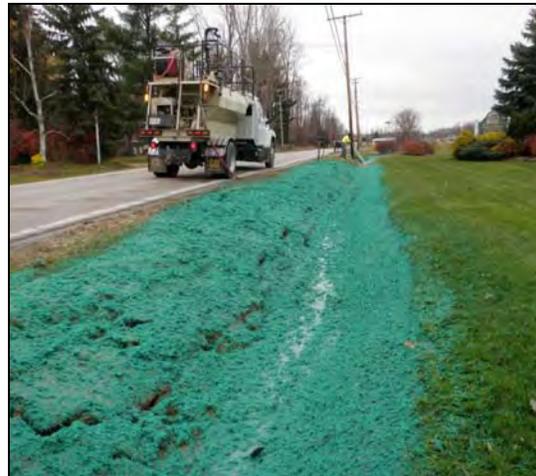
**Figure 2.** Bass Lake Road, Southern Treatment Zone receiving BMP installation on November 7, 2011.

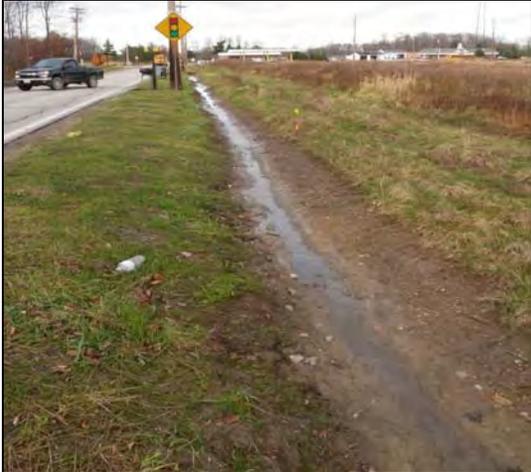
**Figure 3.** Bass Lake Road, Northern Treatment Zone prior to BMP installation November 15, 2011.

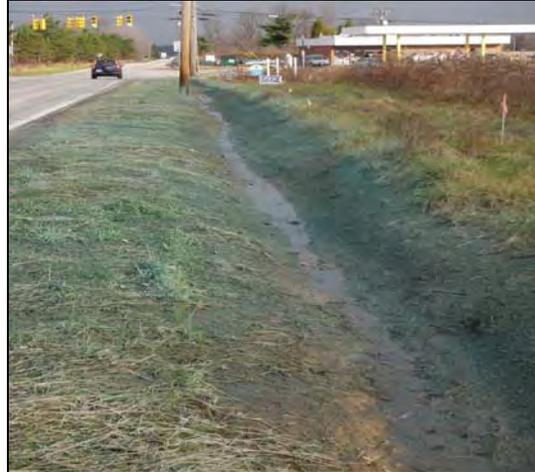
**Figure 4.** Bass Lake Road, Northern Treatment Zone receiving BMP installation on November 17, 2011.

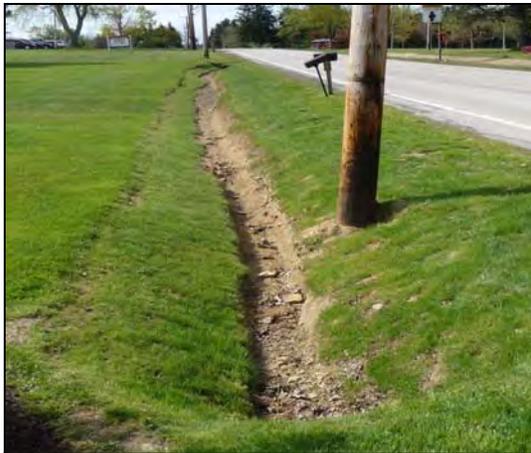
**Figure 5.** Bass Lake Road, Northern Treatment Zone April 27, 2012 full germination of fore slope, back slope and berm.

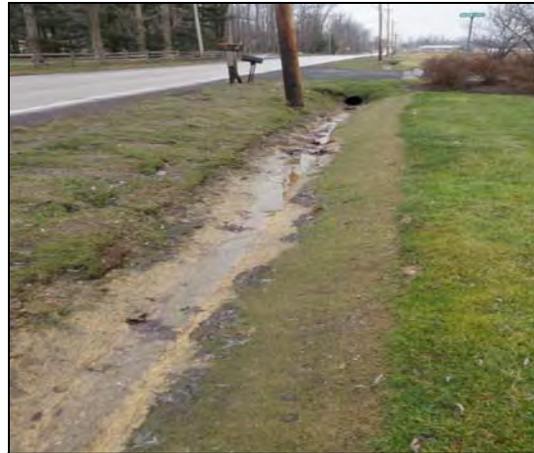
**Figure 6.** Bass Lake Road, Northern Treatment Zone January 2012 germination. Note hydro mulch coverage of soil surface.

The above average temperatures for the 2011-2012 winters reduced snowpack and subjected the site to periodic rain events. The warmer than usual winter also enabled some germination of seed in the months of December 2011 and January 2012 as shown in Figure 6.

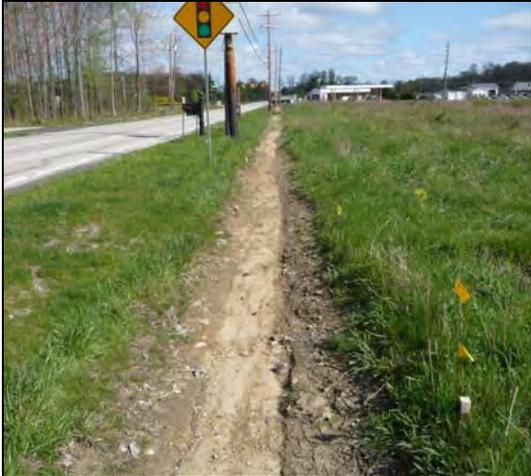
**Figure 7.** Bass Lake Road, Northern Treatment Zone April 27, 2012 showing failed germination on fore and back slope.

Figure 7 shows the unprotected fore slope and back slope in the northern treatment zone. The close-up photograph of the back slope, Figure 8, shows rill erosion forming and rocks in the soil indicating the depth of erosion occurring on the surface of the back slope.

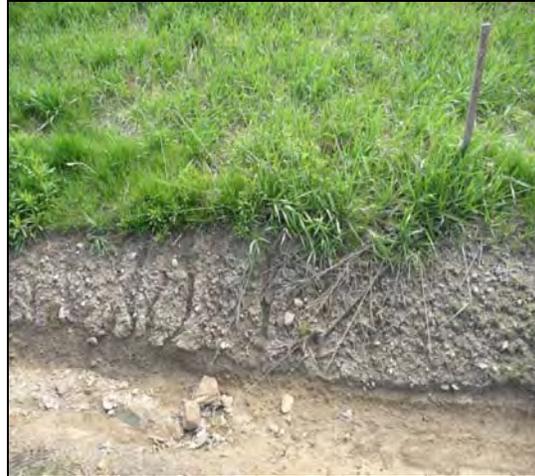
**Figure 8.** Bass Lake Road, Northern Treatment Zone close up photo of back slope showing rill erosion and rock pedestals.

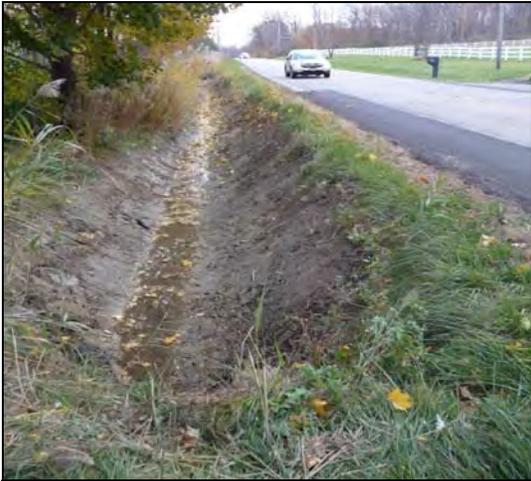
**Figure 9.** Morley Road, Southbound Treatment Zone prior to BMP installation.

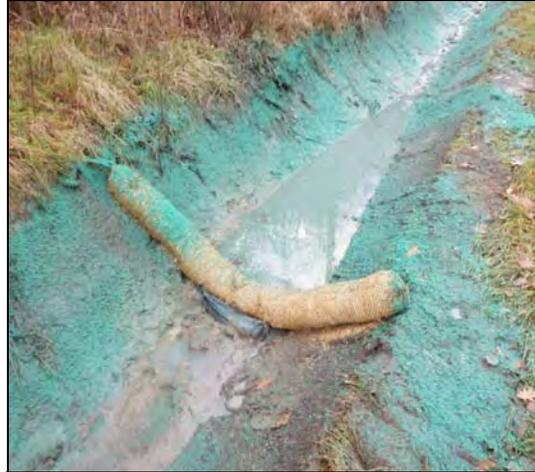
**Figure 10.** Morley Road, Southbound Treatment Zone following BMP installation November 15, 2011.

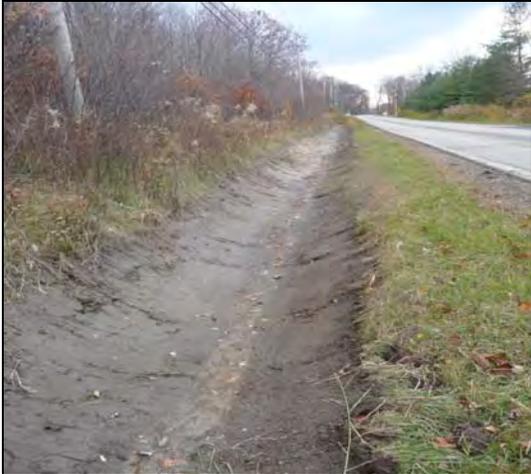
**Figure 11.** Morley Road, Northbound Treatment Zone prior to BMP installation.

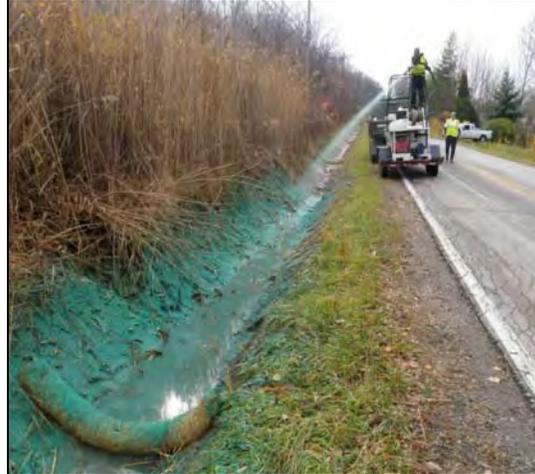
**Figure 12.** Morley Road, Northbound Treatment Zone BMP installation November 15, 2011.

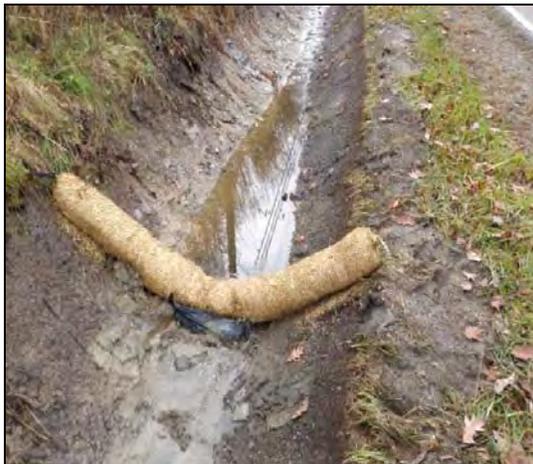
**Figure 13.** Individual straw wattle.

Wattle diameter varies per manufacturer, but typically available sizes are 9, 12 and 20 inches in diameter. Pre-manufactured lengths vary as well with most 9 inch wattles assembled in 25 foot lengths. Length can be adjusted by simply cutting the polypropylene netting at the desired length and re-tying the netting at each end securely with heavy twine or plastic locking ties.

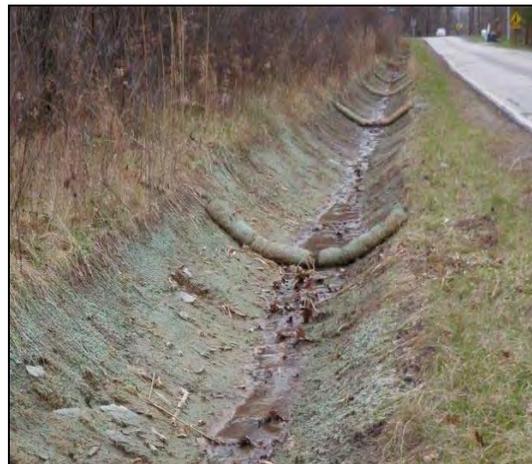
**Figure 14.** Straw wattles in series.

Straw wattles selected for the Morley Road site were 9-inch diameter wattles. The southbound ditch wattle spacing averaged 70 feet between wattles over the 800 linear feet of treatment and the northbound ditch wattle spacing averaged 65 feet over the 812 linear feet of treatment. Wattles were placed to completely cover the width of the ditch with the

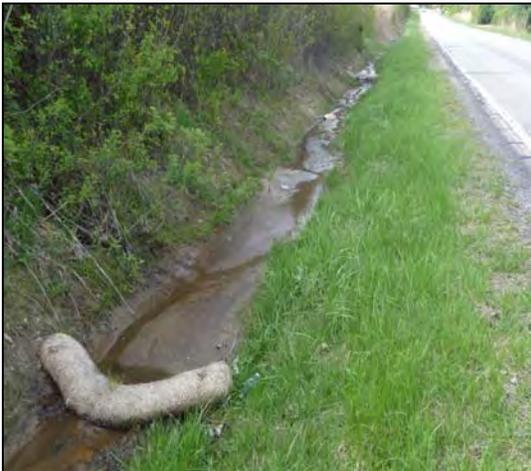
**Figure 15.** Straw wattle trapping sediment. Drainage is flowing from top to bottom in picture.

The straw wattles performed very well throughout the 6 month monitoring period, November 2011 – May 2012, and continued to function through June 2012. Only two of the 22 straw wattles became dislodged from their staking. No wattles were undermined or experienced routing of flow around the ends. The wattles provided stable centerline overflow points without downstream scour. Several of the wattles were able to trap sediments within the straw fiber matrix and created pools immediately upstream that also trapped a significant amount of sediment within the ditch bottom preventing that sediment from further downstream transport.

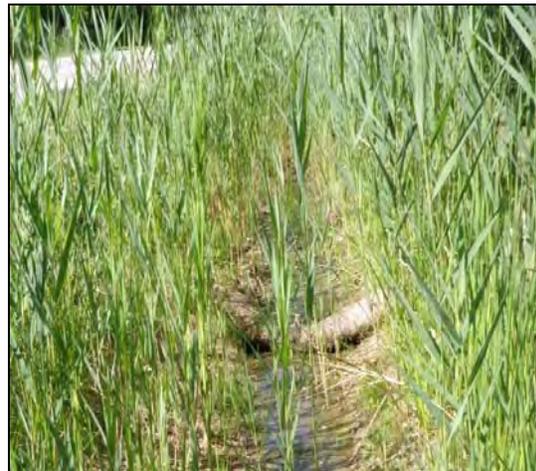
**Figure 16.** Phragmites growth within Morley Road southbound ditch June 2012.

Neither biostimulant appeared to have an advantage over the other at this application site. Although seed germination did occur in the spring of 2012, the ODOT Roadside Seed Mix was quickly over taken by the resurgence of Phragmites within each ditch. The biostimulant additives likely provided a nutrient boost to both the applied seed and existing root system of the Phragmites possibly creating more favorable conditions for stimulated Phragmites recovery.

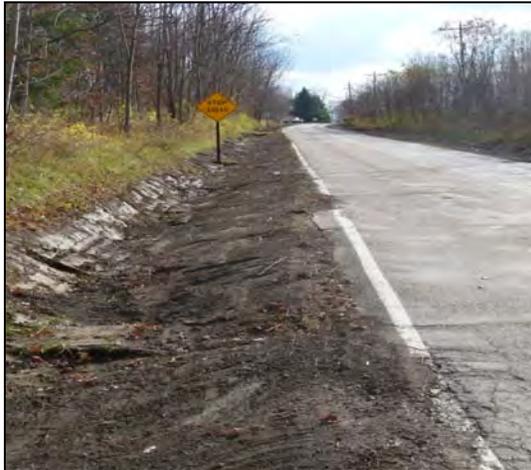
**Figure 17.** Ledge Road, Northbound Treatment Zone prior to BMP installation.

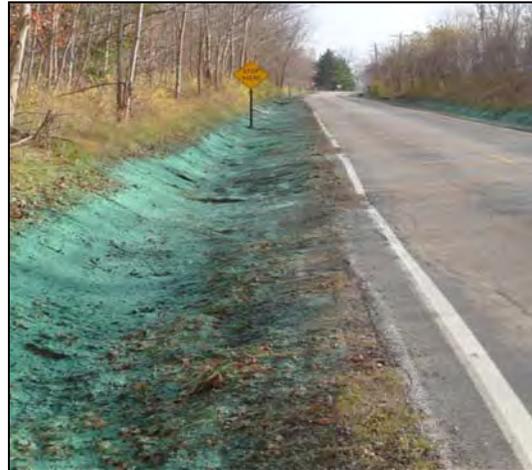
**Figure 18.** Ledge Road, Northbound Treatment Zone BMP installation November 10, 2011.
