# TOLEDO HARBOR LIGHTHOUSE

## SUMMARY OF TASK ONE/PHASE ONE - TECHNICAL REPORT

Toledo Harbor Lighthouse  
Maumee Bay at Lake Erie  
DAP Commission No. 05021

## BUILDING CONDITION ASSESSMENT REPORT

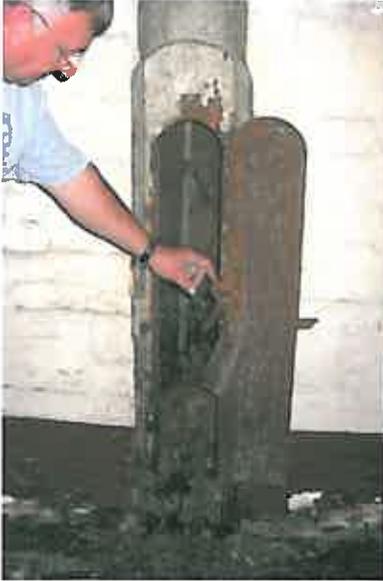
**Photo 6 Counterweight  
at center column (Basement)**

There is a 12" diameter cast iron center column extending from the Basement to the Lantern Room floor, housing the counterweight assembly which provided the rotational force to operate the original beacon and its turntable (Photo 6). All columns bear on cast iron base plates set into the Basement floor slab bearing on concrete grade beams. Lateral force resistance is provided by the exterior masonry envelope acting as shear walls.

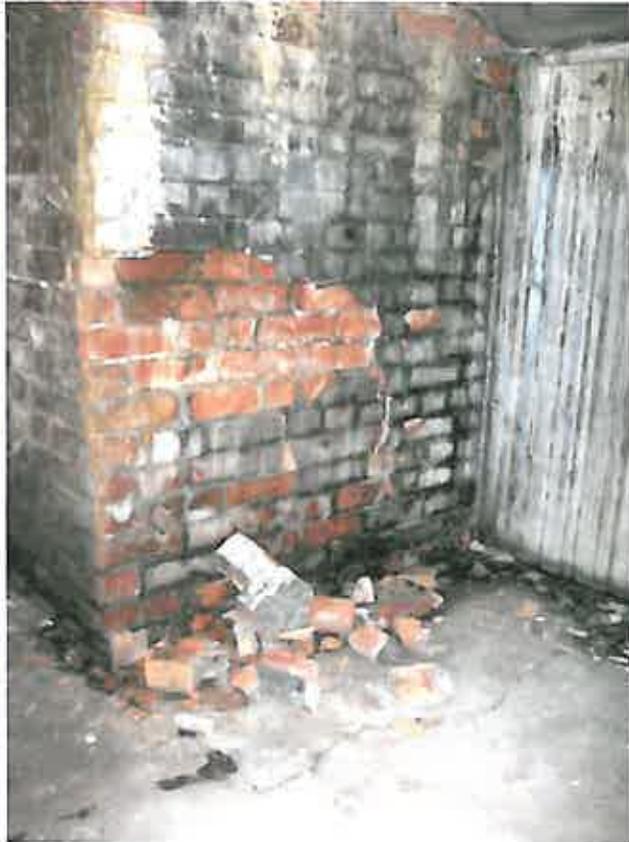
**Photo 7 Basement Masonry Walls**

Basement perimeter walls are 19" thick (5 wythes), constructed of common brick with limestone facing extending 3 feet above grade. The original lime wash interior finish has mostly dissolved at the building perimeter from moisture intrusion. Interior mortar joints remain in good condition (Photo 7). Corners of the archway entries into the storage vaults at each end show stress fractures and damage, although horizontal joint alignment do not indicate any vertical displacement that would indicate settling (Photo 8). Some areas of perimeter wall along the northwest side beneath the Engine Room show evidence of lateral displacement into the room. This is consistent with freeze thaw damage at the inner masonry wythe, although there is a possibility this may be related to external pressure from Lake ice. Further investigation is warranted.

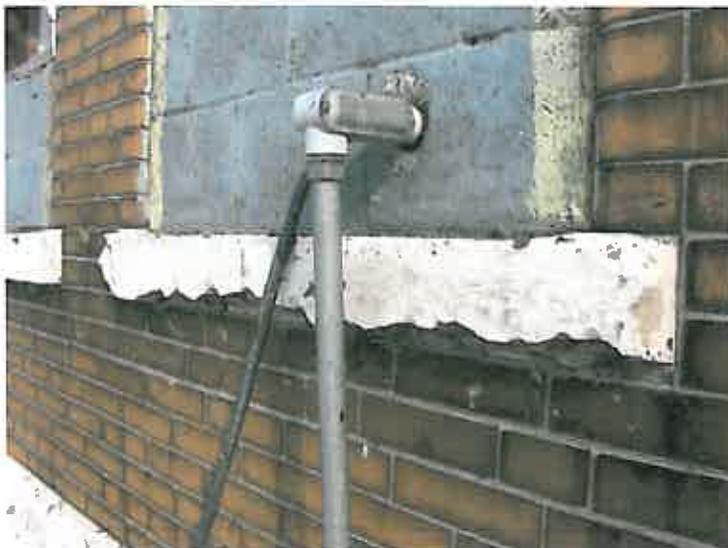
**Photo 9 Base of Limestone  
Water Table**

Repairs done in 1989 included a new concrete deck over the platform utilizing elastomeric joint seals that are failing. There is also a substantial gap at the perimeter of the building with no expansion joint filler (Photo 9). Both conditions are primary contributing factors to uncontrolled water entry into the basement. New remedial joint sealants and deck coating will be included in the scope of renovation work.

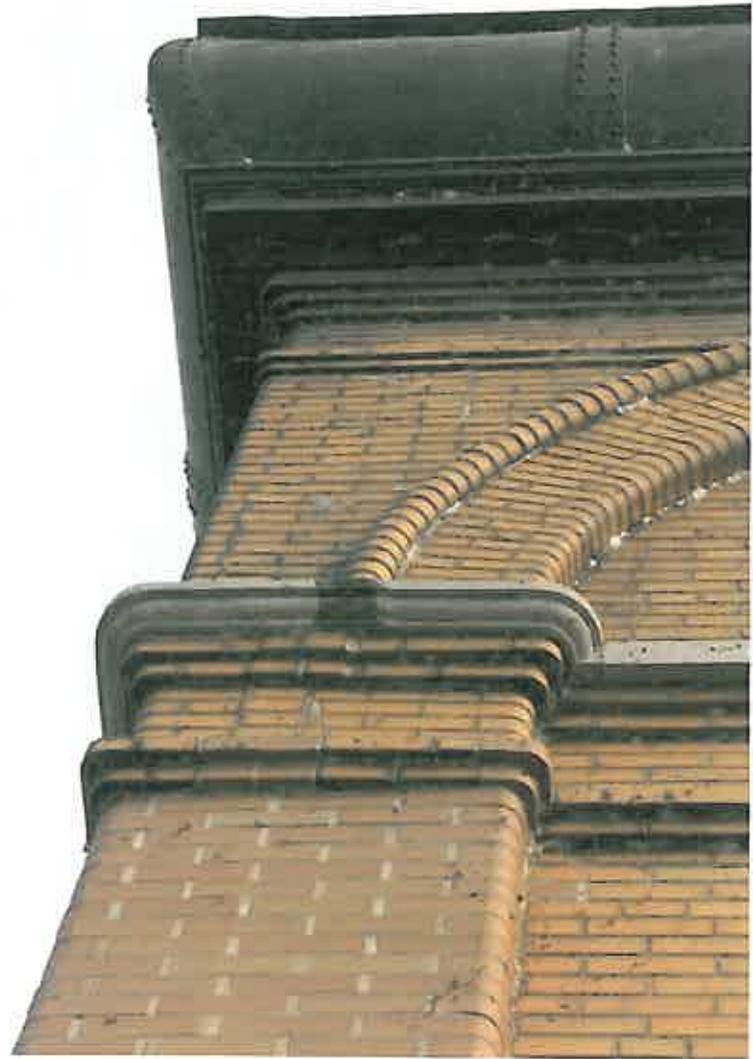
**Photo 11 Limestone cornice  
repair (1989)**

Some carbonation of the limestone is observed, but there is only slight degradation (peeling) of a few units and no exfoliation. There is physical damage to the face, corners and underside on a few of the window sills that will require patching (Photo 10), but for the most part the stone is in excellent condition. The limestone cornice belting exhibits signs of greater wear from exposure with some visible cracks and displacement of previous repairs (Photo 11). These will be properly addressed during the renovation.
