Final Report

*Stream Habitat and Land Use Assessment
for North Central Tributaries to Lake Erie*

Water Quality Laboratory
Heidelberg College
Tiffin, Ohio 44883

Submitted in partial fulfillment of Grant SG 80-98, Lake Erie Protection Fund

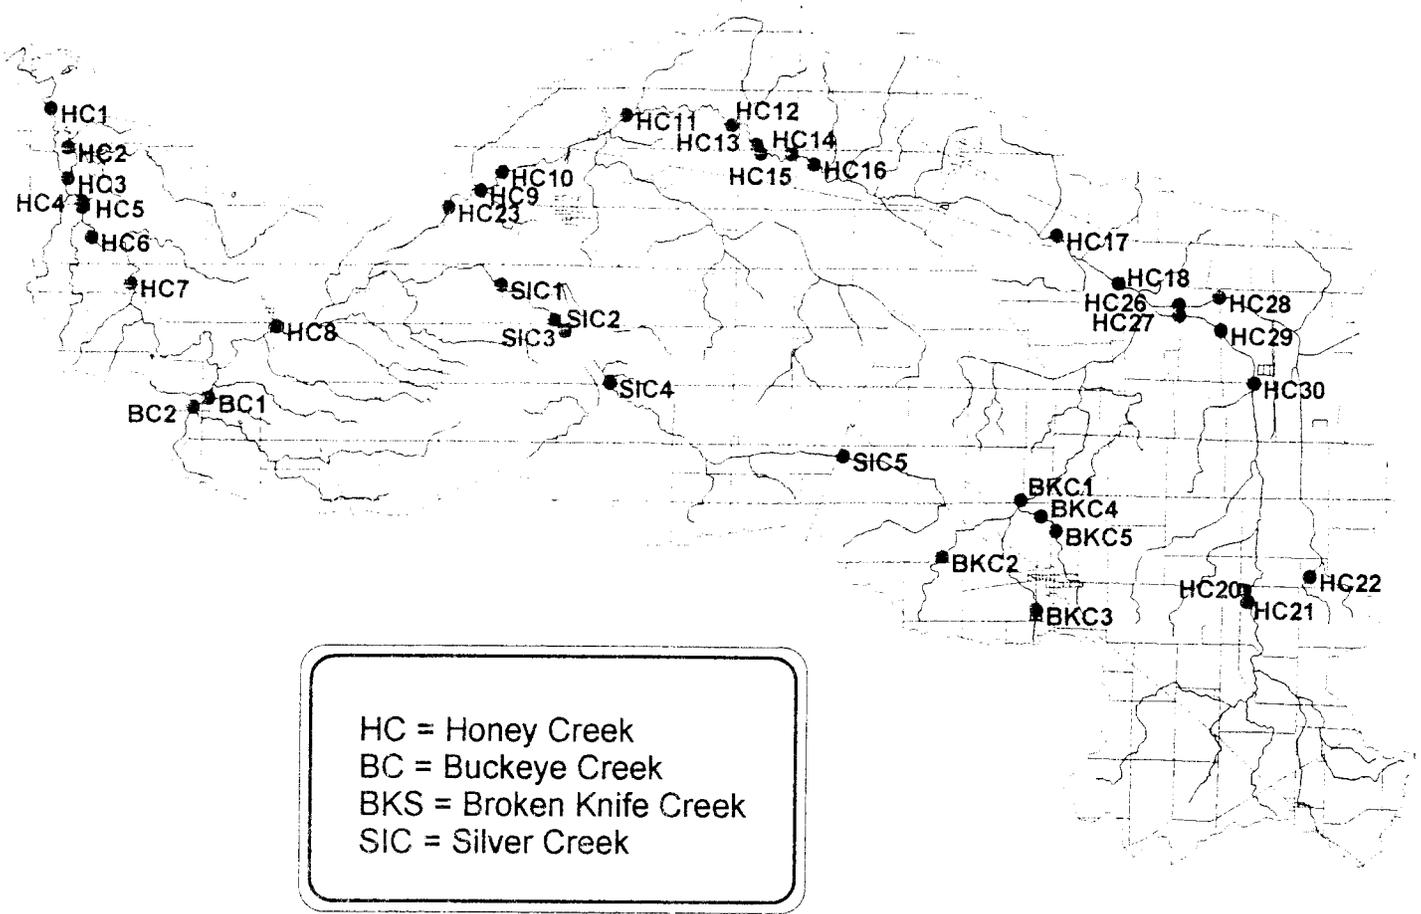
Figure 5. Location of sites in Honey Creek Watershed.

A total of 23 sites were surveyed on Honey Creek in Seneca, Huron, and Crawford Counties. There were 3 sites for Buckeye Creek in Seneca County and 5 sites for both Silver Creek and Broken Knife Creek in Seneca and Crawford County. Locations of the sites in the Honey Creek Watershed are illustrated in Figure 5.

It is apparent from the data in Figure 5 and 6 that, as streams become smaller, citizens QHEI values tend to decrease. These results are consistent with observations of the OEPA for the agricultural watersheds of northwestern Ohio. The habitat of small

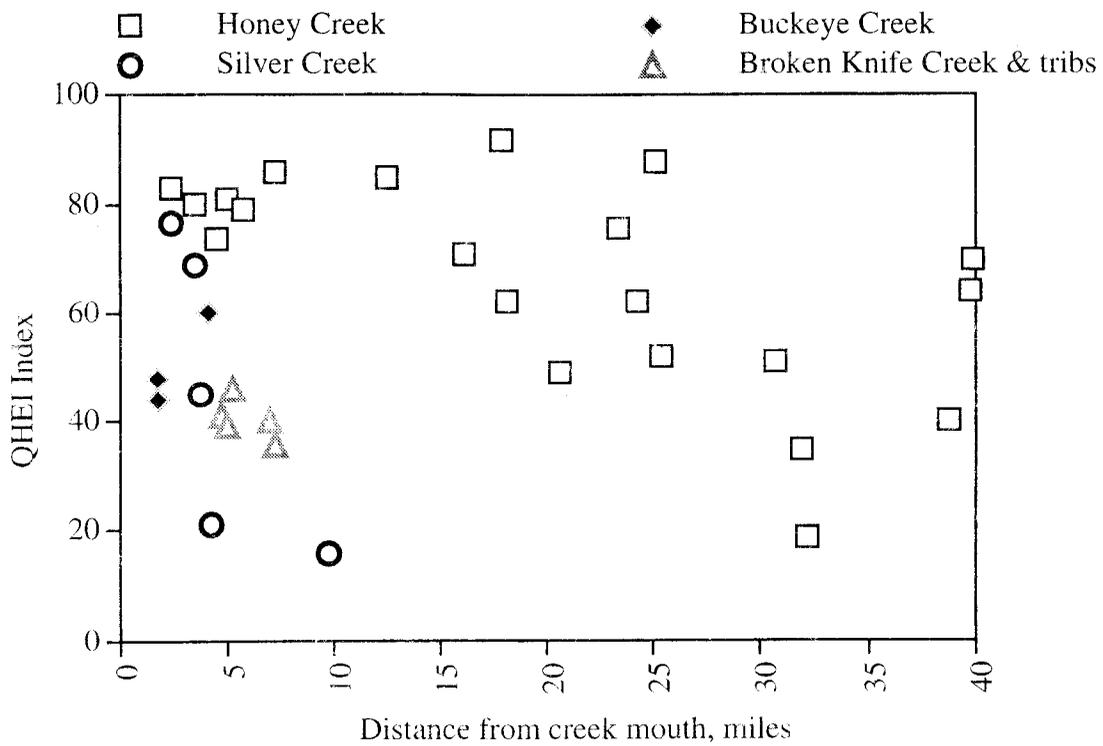
Figure 6. QHEI scores in relation to stream mile points.

The QHEI scores for stations in the Honey Creek watershed are illustrated in Figure 6 in relation to the mile points for each stream. For Honey Creek, the QHEI scores were high in the lower portions of the stream (low mile points), intermediate in the mid-portion of the stream and lowest in the upper portion of the stream. The average QHEI score for Honey Creek was 63. QHEI indices for the tributaries to Honey Creek (Buckeye Creek, Silver Creek and Broken Knife Creek) were generally lower than the average for Honey Creek. Only two stations on Silver Creek had scores above the average score for Honey Creek.

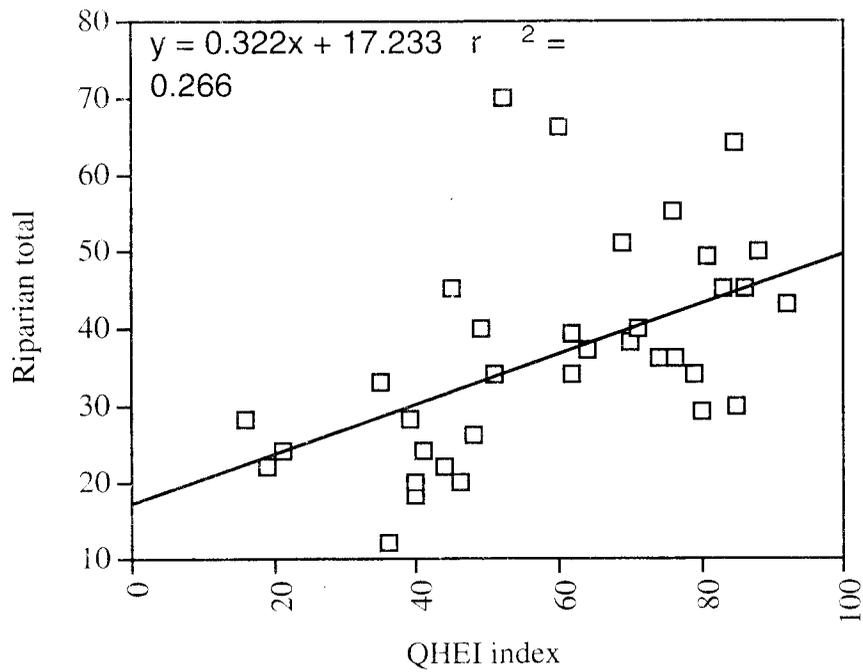
Figure 7. Relationship between QHEI scores and Riparian Scores for stations in the Honey Creek Watershed.

The relationship between the QHEI score and the riparian score for all of the Honey Creek watershed stations is shown in Figure 7. In general, as the QHEI scores increase, the riparian scores also increase. While the QHEI score does include a riparian component, its maximum value is about 15 out of 106 points.

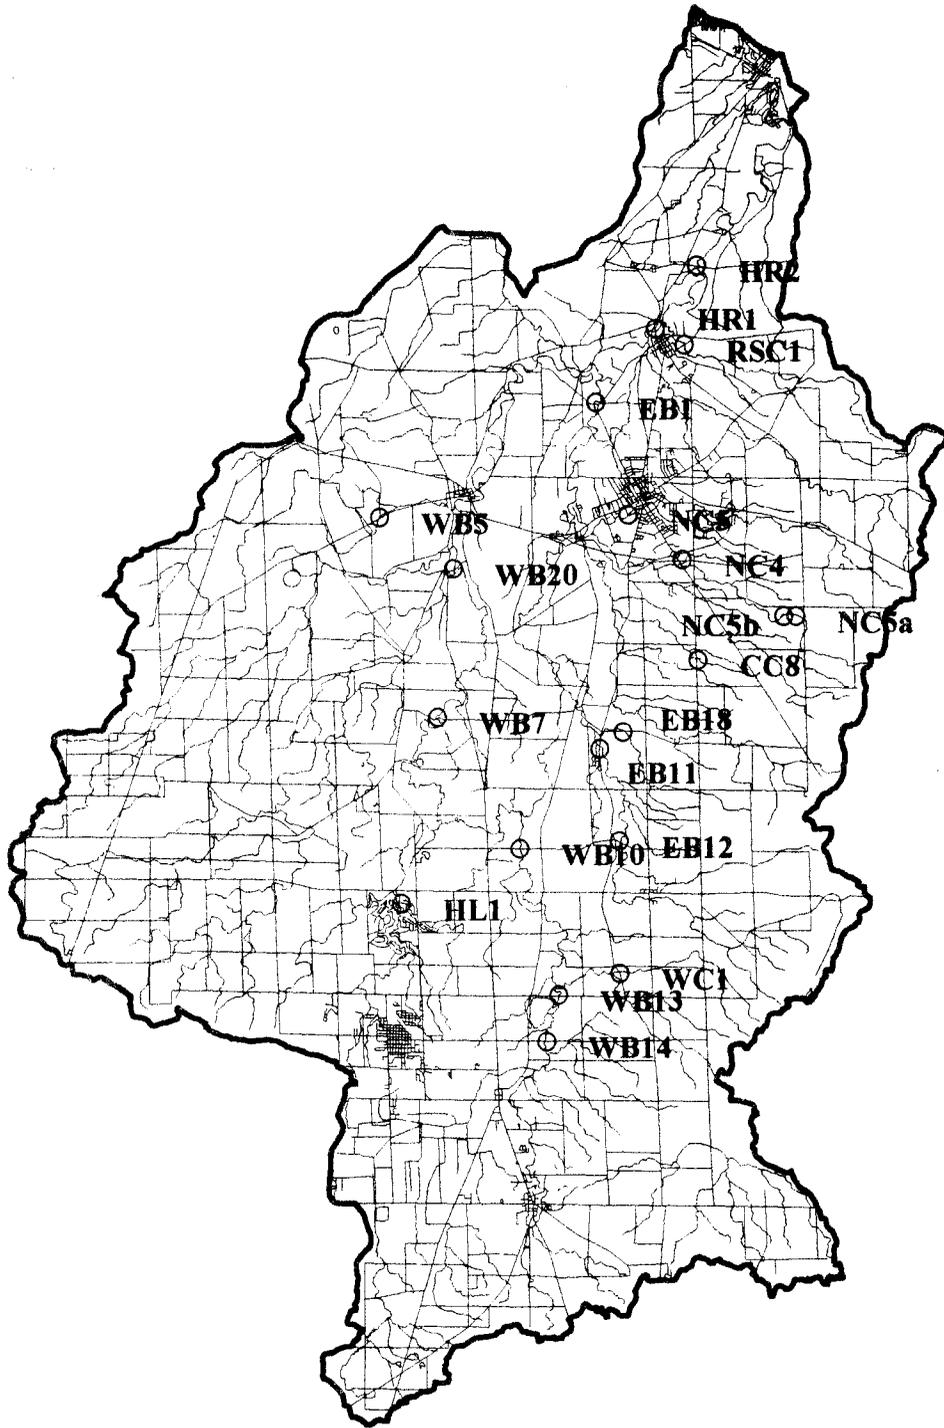
Figure 8. Location of sites in Huron River Watershed.

Site locations are illustrated on the Huron River Watershed map in Figure 8.
